EVO 79-599

Heat Exchanger Maintenance Kit

MNT 94309 B

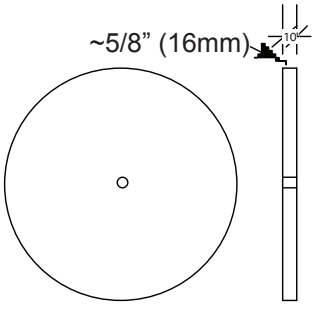
<p>FIB 74902 Insulation Rear Wall</p>

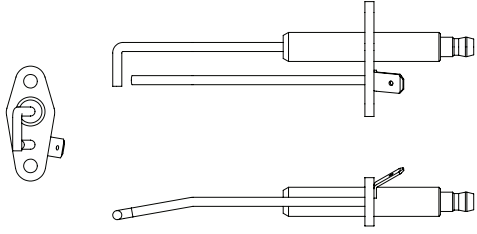
<p>PLT 94318 A Ignitor Replacement Kit</p>

<p>Ignitor Adjustment/Mounting Instructions</p>					
<p>~5/16" (8-10mm)</p>

<p>~1/8" (3.50mm)</p>
